<b>FIELD REPORT</b>		File Number: 0422-113-00
	Project: Brighton Board Walk Landslide Evaluation		Date: June 8, 2015
600 DUPONT STREET BELLINGHAM, WA 98225 (360) 647-1510	Owner: Island County Public Works	Time of Arrival: 11:00am	Report Number: 5
	Location: Clinton, Washington	Time of Departure: 12:45 pm	Page: 1 of 3
Prepared by: Sean Cool, PE	Weather: Sunny, warm (70s)	Travel Time: 4 hrs	Permit Number:
Purpose of visit: Landslide Evaluation	Upon arrival to the site I assessed personal safety hazards: <input checked="" type="checkbox"/> Yes or <input type="checkbox"/> Referred to Site Safety Plan and Safety Tailgate if applicable Safety Hazards Were Addressed by : <input type="checkbox"/> Staying Alert to Construction and Equipment Hazards <input type="checkbox"/> Other (describe)

At the request of Connie Bowers with Island County Public Works (ICPW), GeoEngineers performed a site visit to provide continued periodic site observation related to past landslide activity at the Brighton Board Walk/Campers Row Walk Landslide just north of Clinton, Washington. The purpose of our visit was to evaluate any significant changes in site conditions that would affect the hazard to residents an

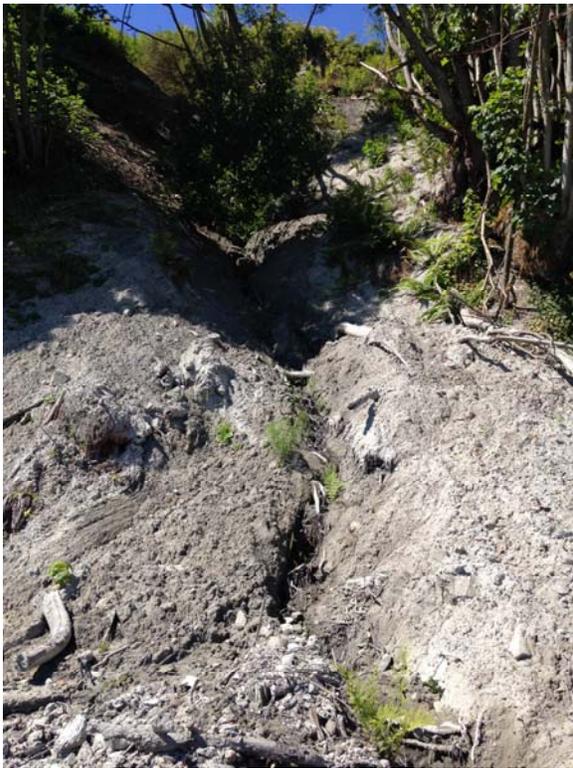
- We did not observe any substantive changes at the site since our last visit on March 14, 2015. Evidence that landslide movement had not progressed included sparse vegetation (primarily ferns and horsetail) beginning to grow in areas of the two primary slide chutes, no significant visible changes in surface topography, and no significant new deposition in the runout/fan area at the toe of the slide area (Photos 1 and 2 below). There was no visibly apparent change to the central possible slump block between the two landslide chutes.

Photo 1 - South landslide chute with new sparse vegetation.

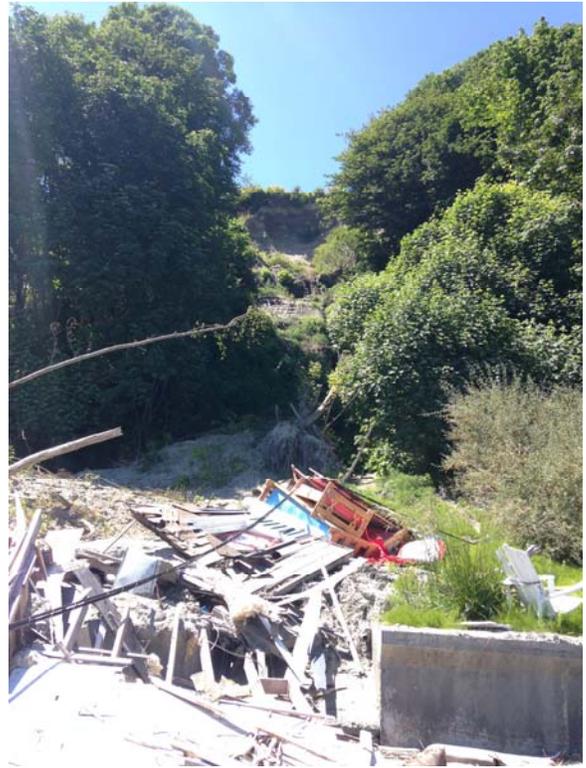
- The upper portion of the landslide scarp is still near vertical, and possibly undercut slightly, with a mid-slope bench below the slide scarp. Based on review and comparison with past site photos, there was no readily apparent change to this area; however, it was difficult to evaluate directly because of site access.

Photo 2 - North landslide chute with new sparse vegetation and showing scarp at top of slope.
