**ISLAND COUNTY COMMISSIONERS' WORK SESSION SCHEDULE**  
**FEBRUARY 19, 2025**

# ISLAND COUNTY SHORELINE ARMOR MAPPING & CHANGE ANALYSIS

JUNE 5<sup>TH</sup> LEADERSHIP COUNCIL ISLAND LIO LOCAL FORUM

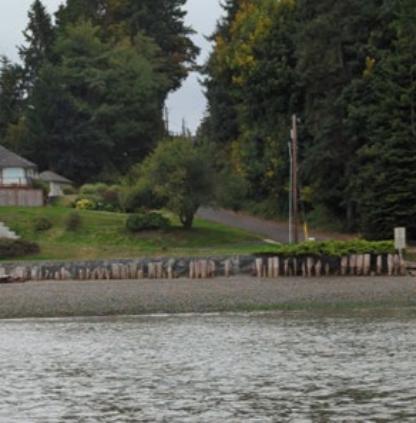
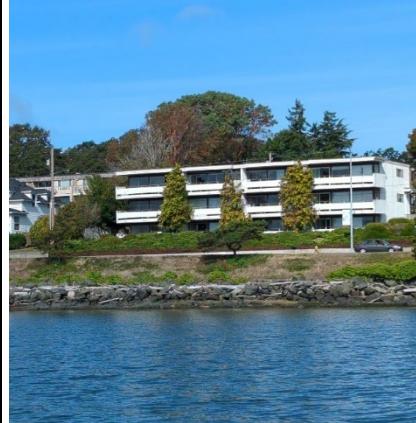
Figure 1. Representative Examples of Hard Shoreline Armor Encountered in Island County.

<b>Concrete Bulkhead with Derelict Vertical Wood Piles</b>	<b>Stacked Rock Revetment</b>	<b>Creosote-Treated Wooden Bulkhead Adjacent to a Metal Sheet-Pile Wall</b>

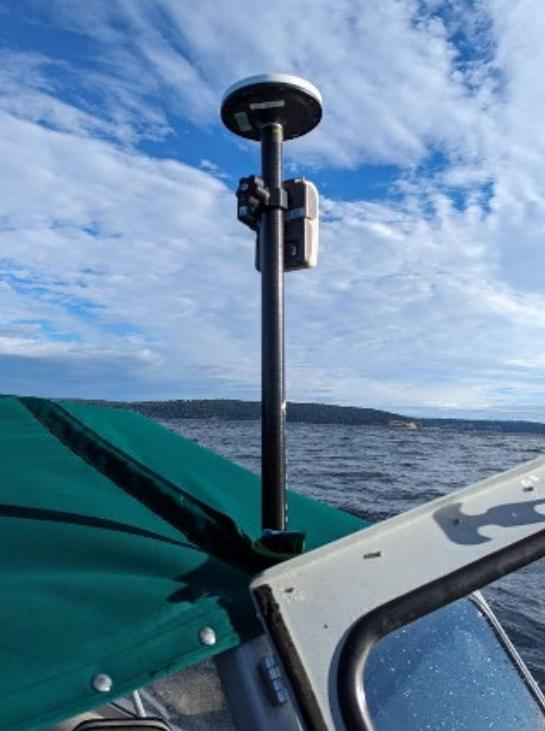
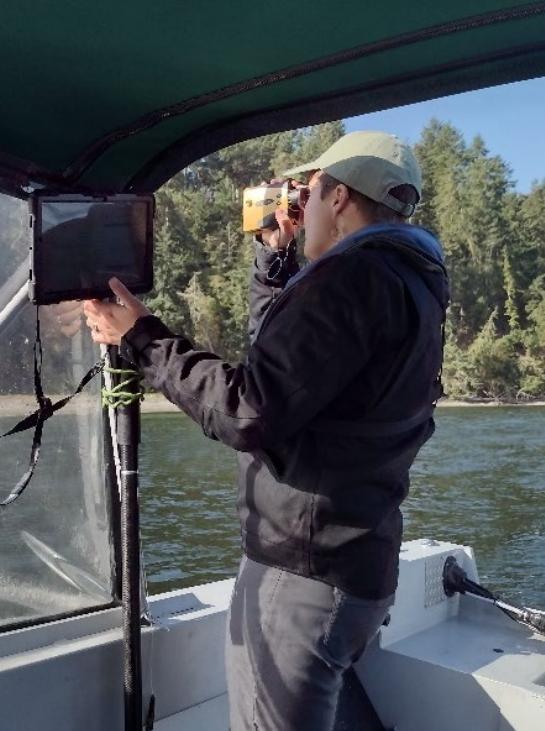
<p>Figure 2.1. EOS Arrow 100 GPS Receiver and Antenna Mounted to the Field Boat.</p>	<p>Figure 2.2. Field Staff Conducting Offset Mapping Using a TruPulse 360-Series Laser Rangefinder and Esri FieldMaps Application.</p>

Mapping was conducted using an EOS Arrow 100 sub-meter GPS unit with real-time kinematic (RTK) corrections (Figure 2.1), which received virtual offsets from a linked LaserTech TruPulse 360-series laser rangefinder (Figure 2.2). A TruPulse 360B laser rangefinder was used during the first 8 days of data collection, and a TruPulse 360R was used for the final 3 days of mapping. Laser rangefinders were calibrated by following manufacturer guidelines at the beginning of each field day. The accuracy of the laser rangefinder was periodically evaluated across each day.

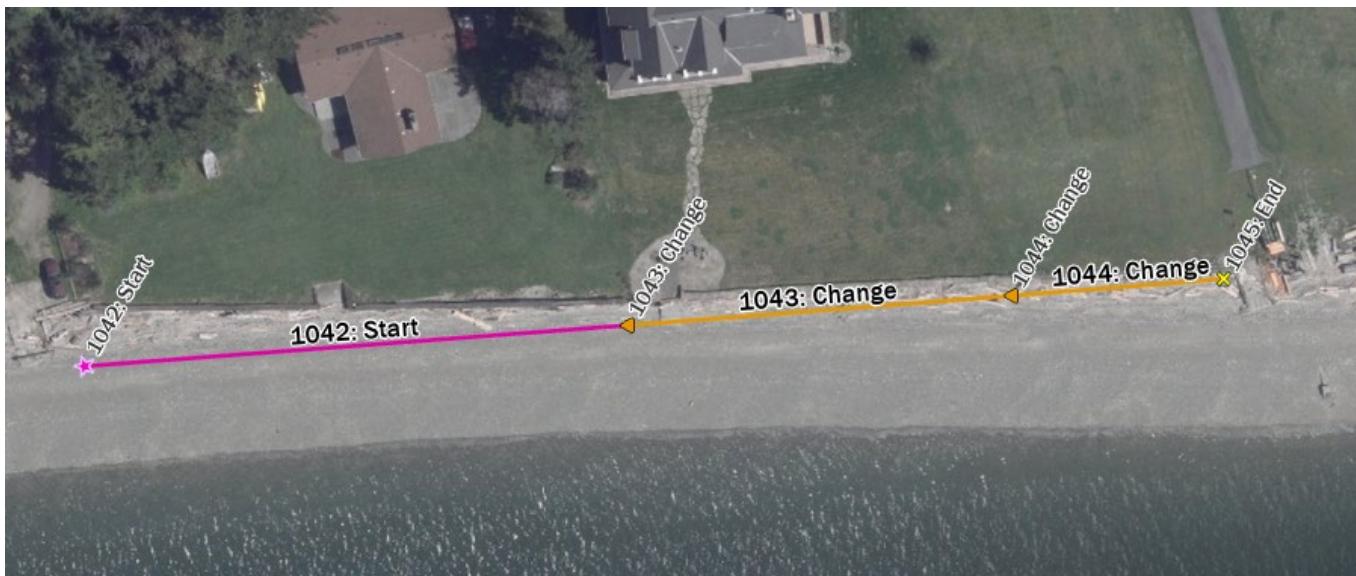
Figure 3. Example of Armor Lines Generated Using Sequentially Assigned Identifiers, with Attributes Populated from Start to End.

Following review and validation of all mapped shoreline armor points, GPS-collected and remotely mapped armor attributes were processed from individual armor vertices into polyline features in ArcGIS Pro. Herrera applied a semi-automated approach based on the approach described in CGS (2018) to improve data production efficiency. Rather than manually digitizing each armor segment from mapped offset points, each point was assigned a sequential identifying number derived from the alongshore direction in which mapping was conducted. For example, a section of continuous armor would be comprised of increasing ID numbers from start to end (e.g., a set of three points—start, change, end—with ID numbers 347, 348, 349; Figure 3). After ID numbers were assigned, armor segments were automatically generated using the “points to lines” geospatial processing tool; the attributes of each armor segment were assigned from the leading point in the sequence. Lines generated with an “end”-type point as their origin were deleted, as these represented areas with no shoreline armor.

After lines were generated to describe the extent of shoreline armor from offset-mapped points, the length of each armor segment was populated to a new “pre-snap armor length” field. This allowed for preservation of initial armor extents prior to conforming to the WDNR ShoreZone Shoreline (Berry, et al., 2001).

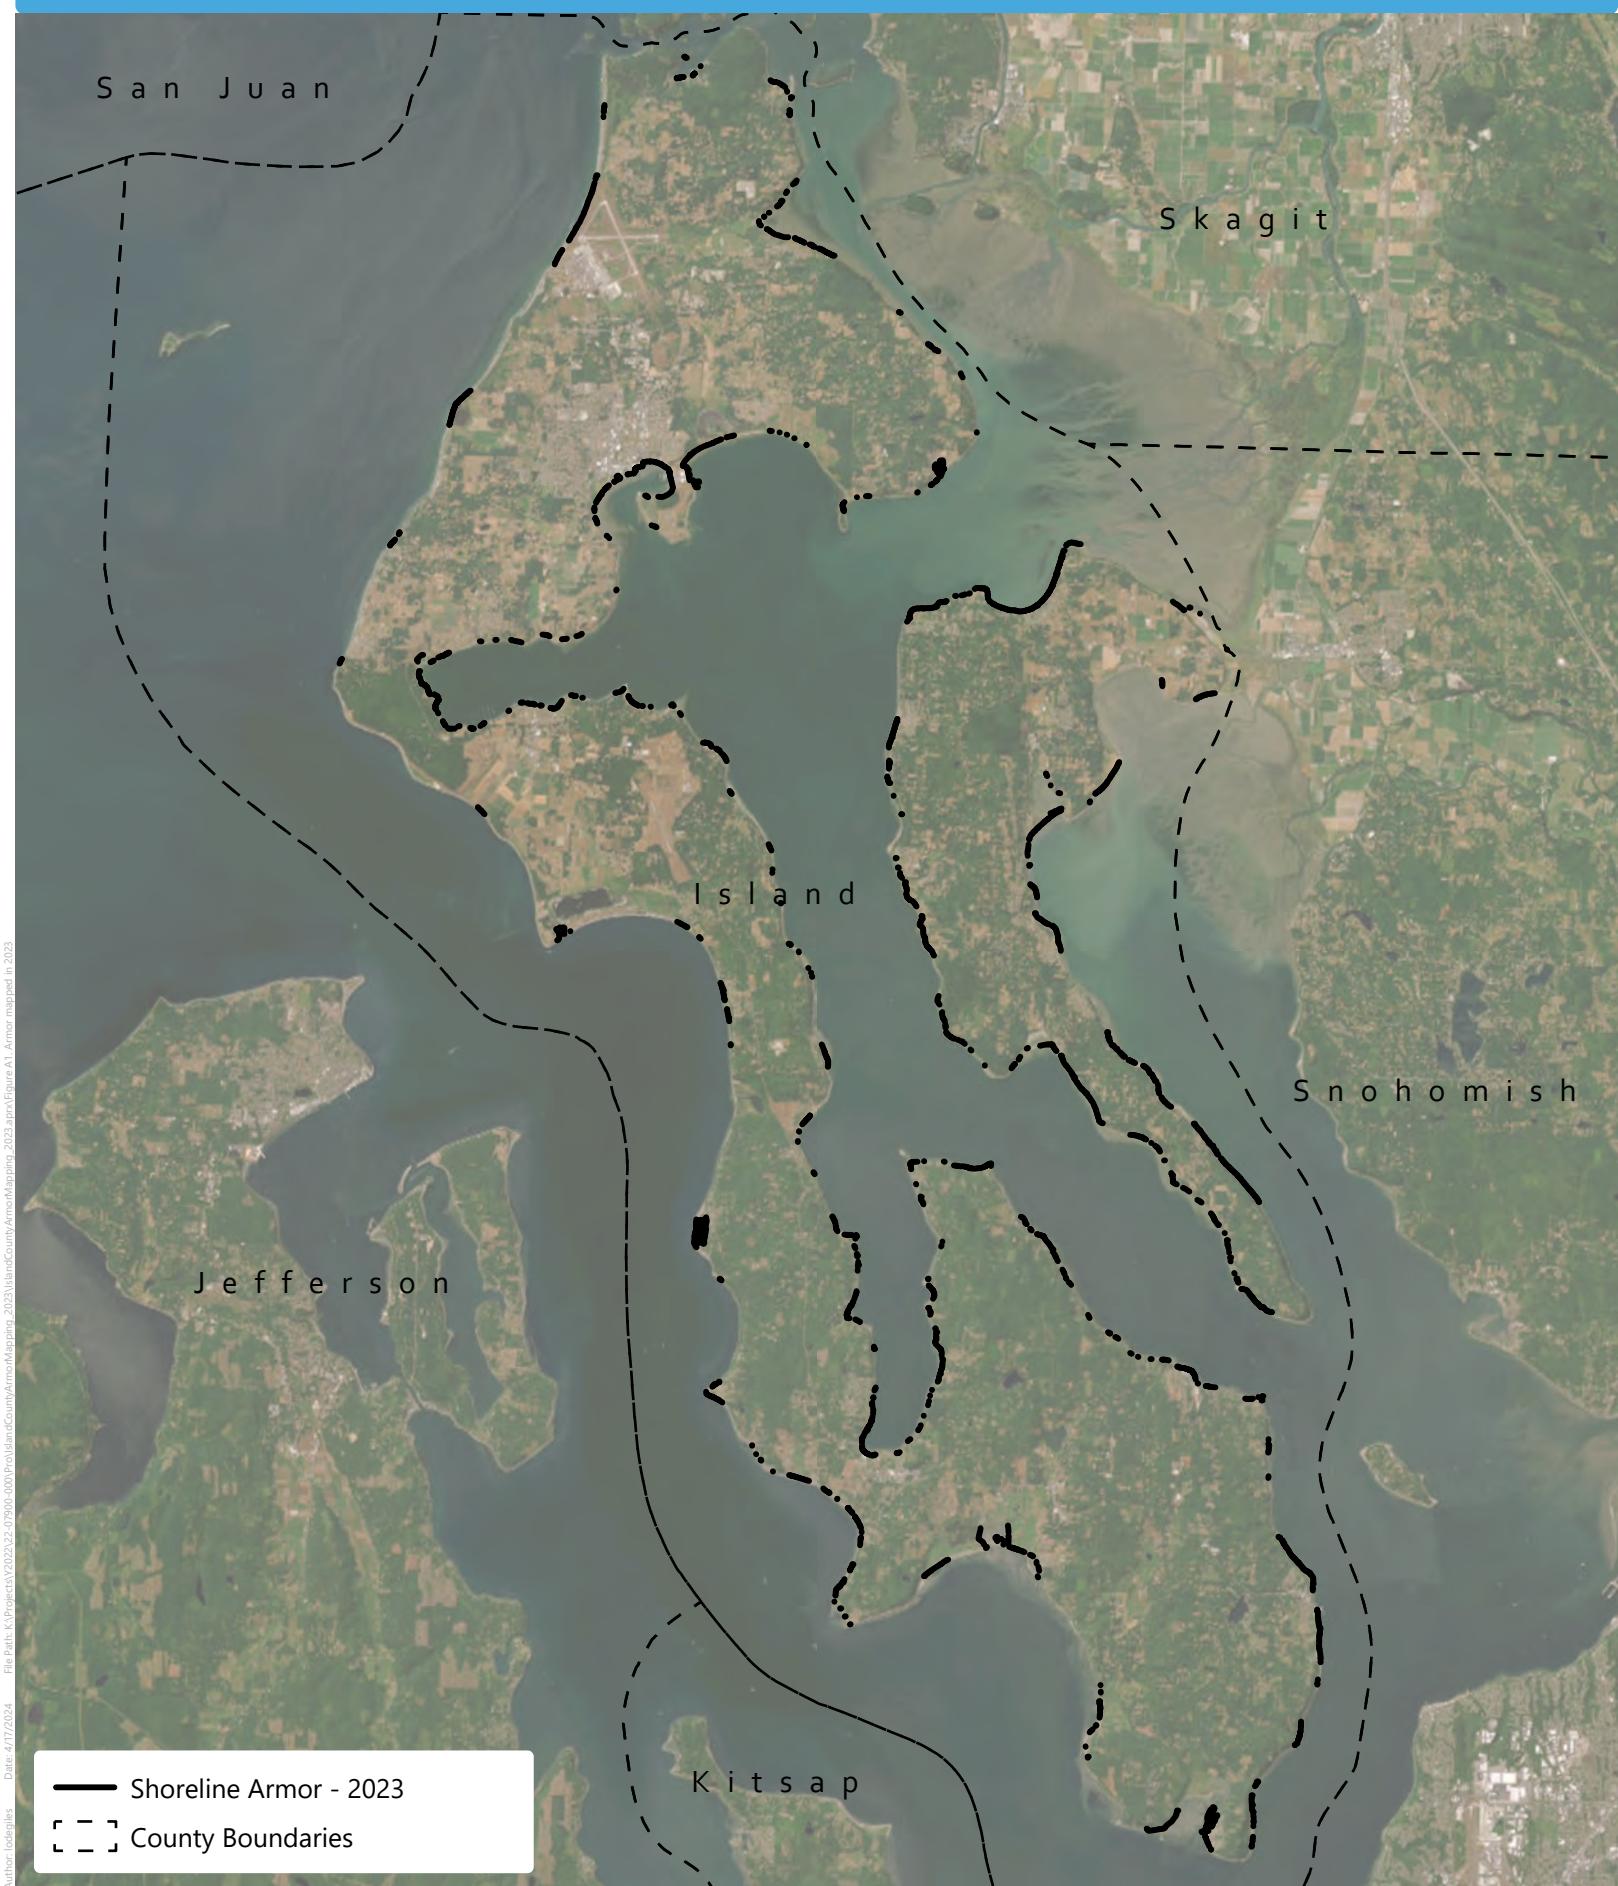
Figure A1.1 - Armor Mapped in 2023, Island County

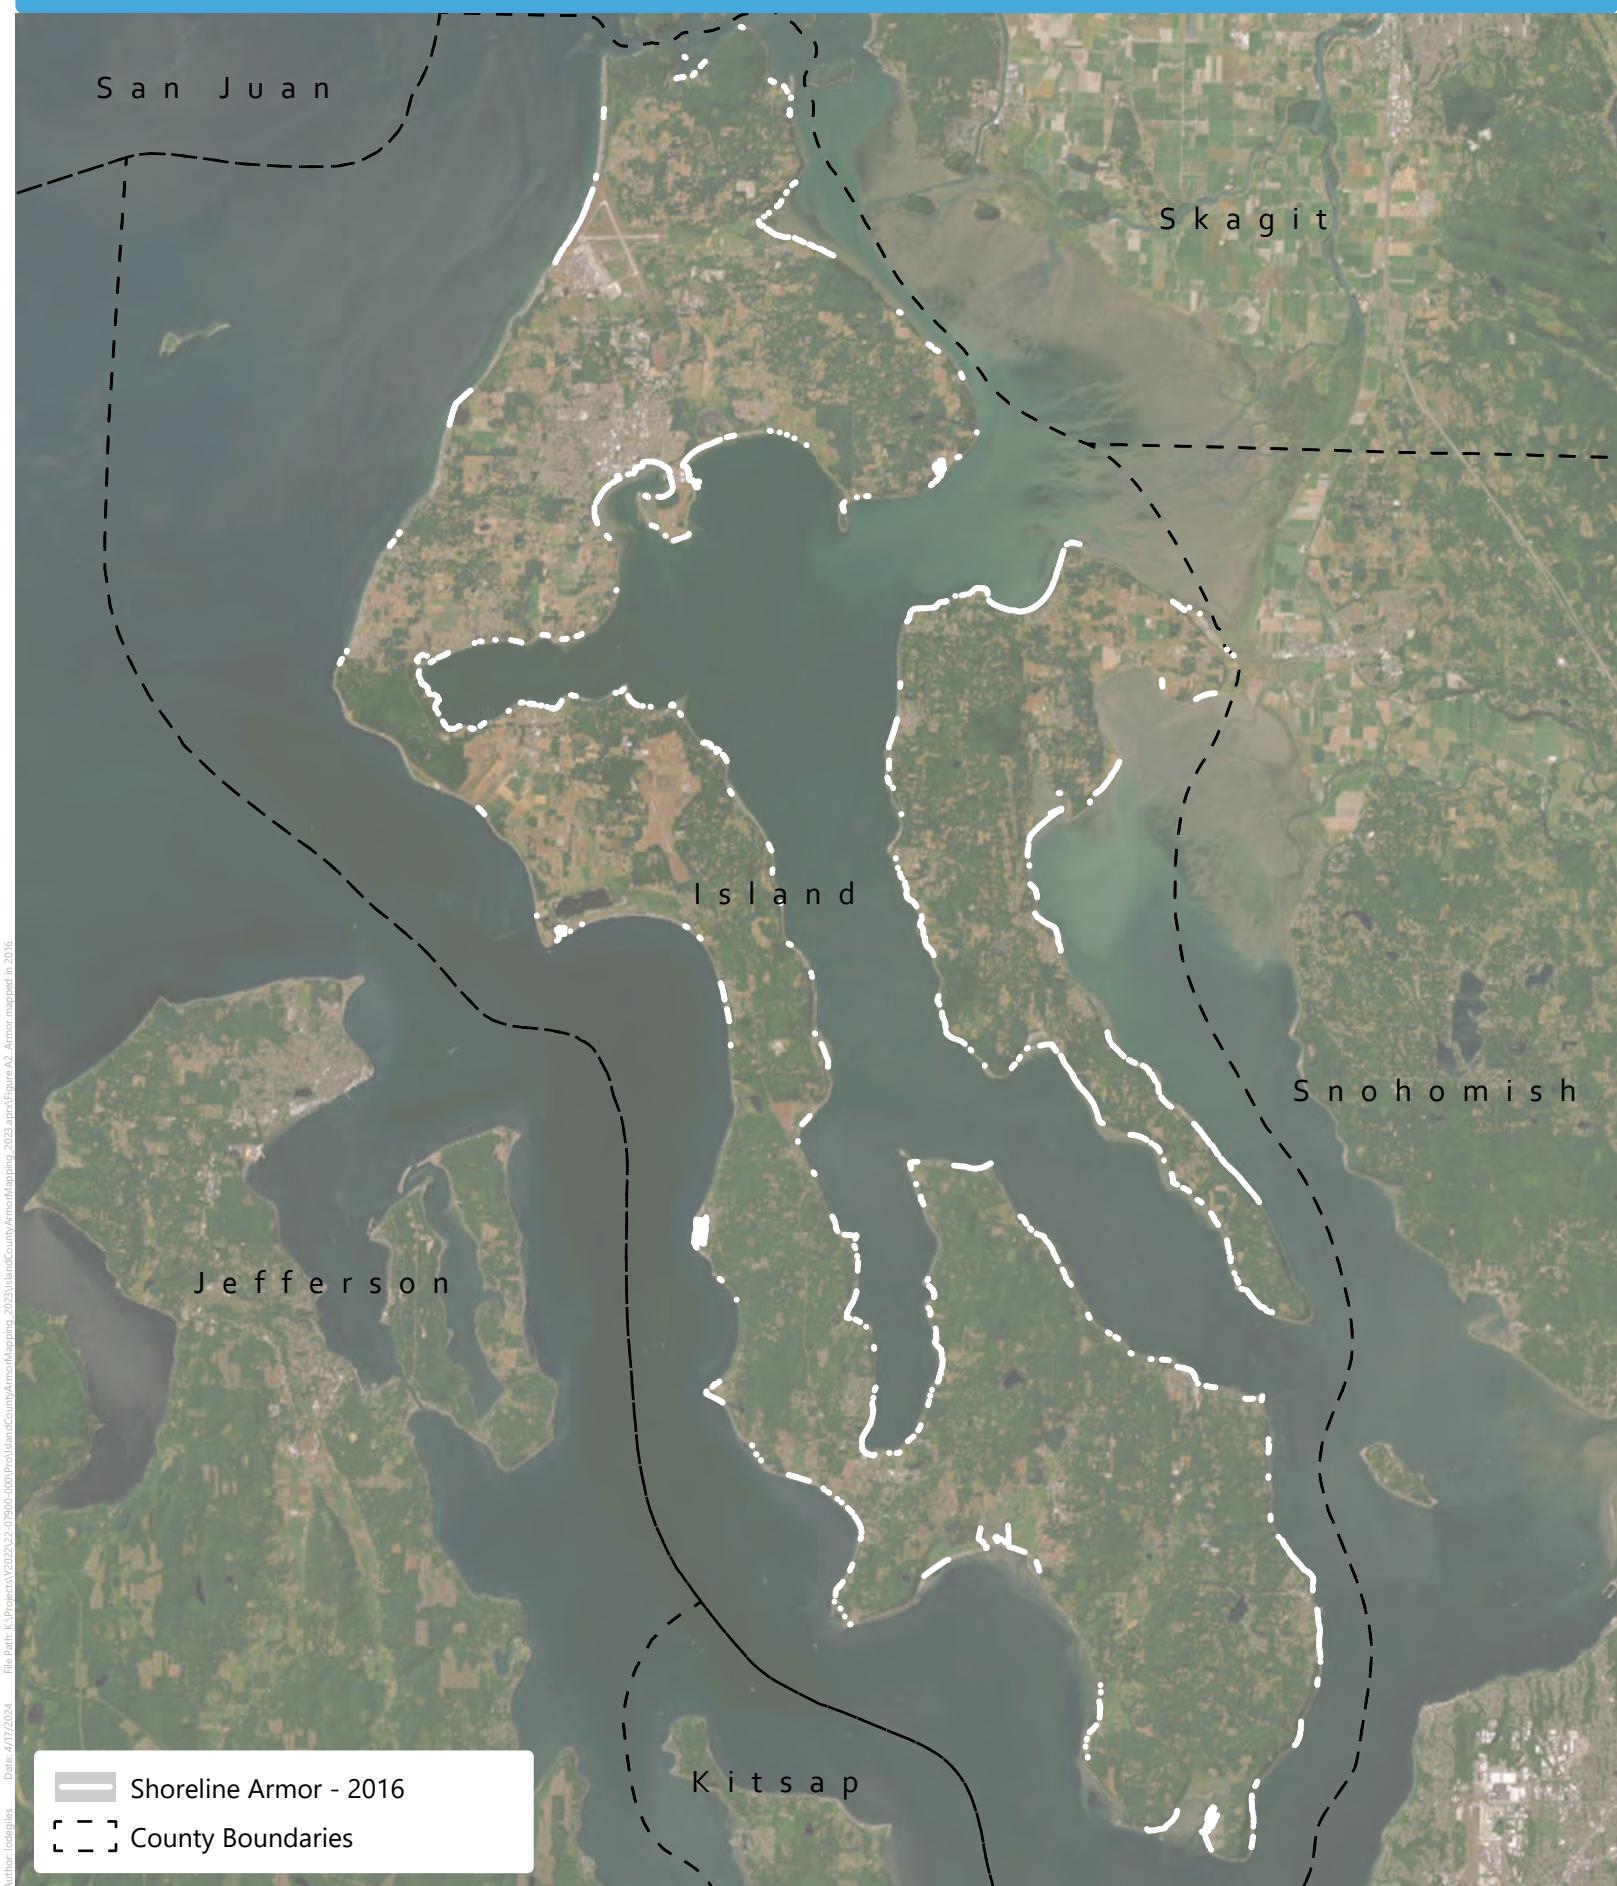
Figure A2.1 - Armor Mapped in 2016, Island County

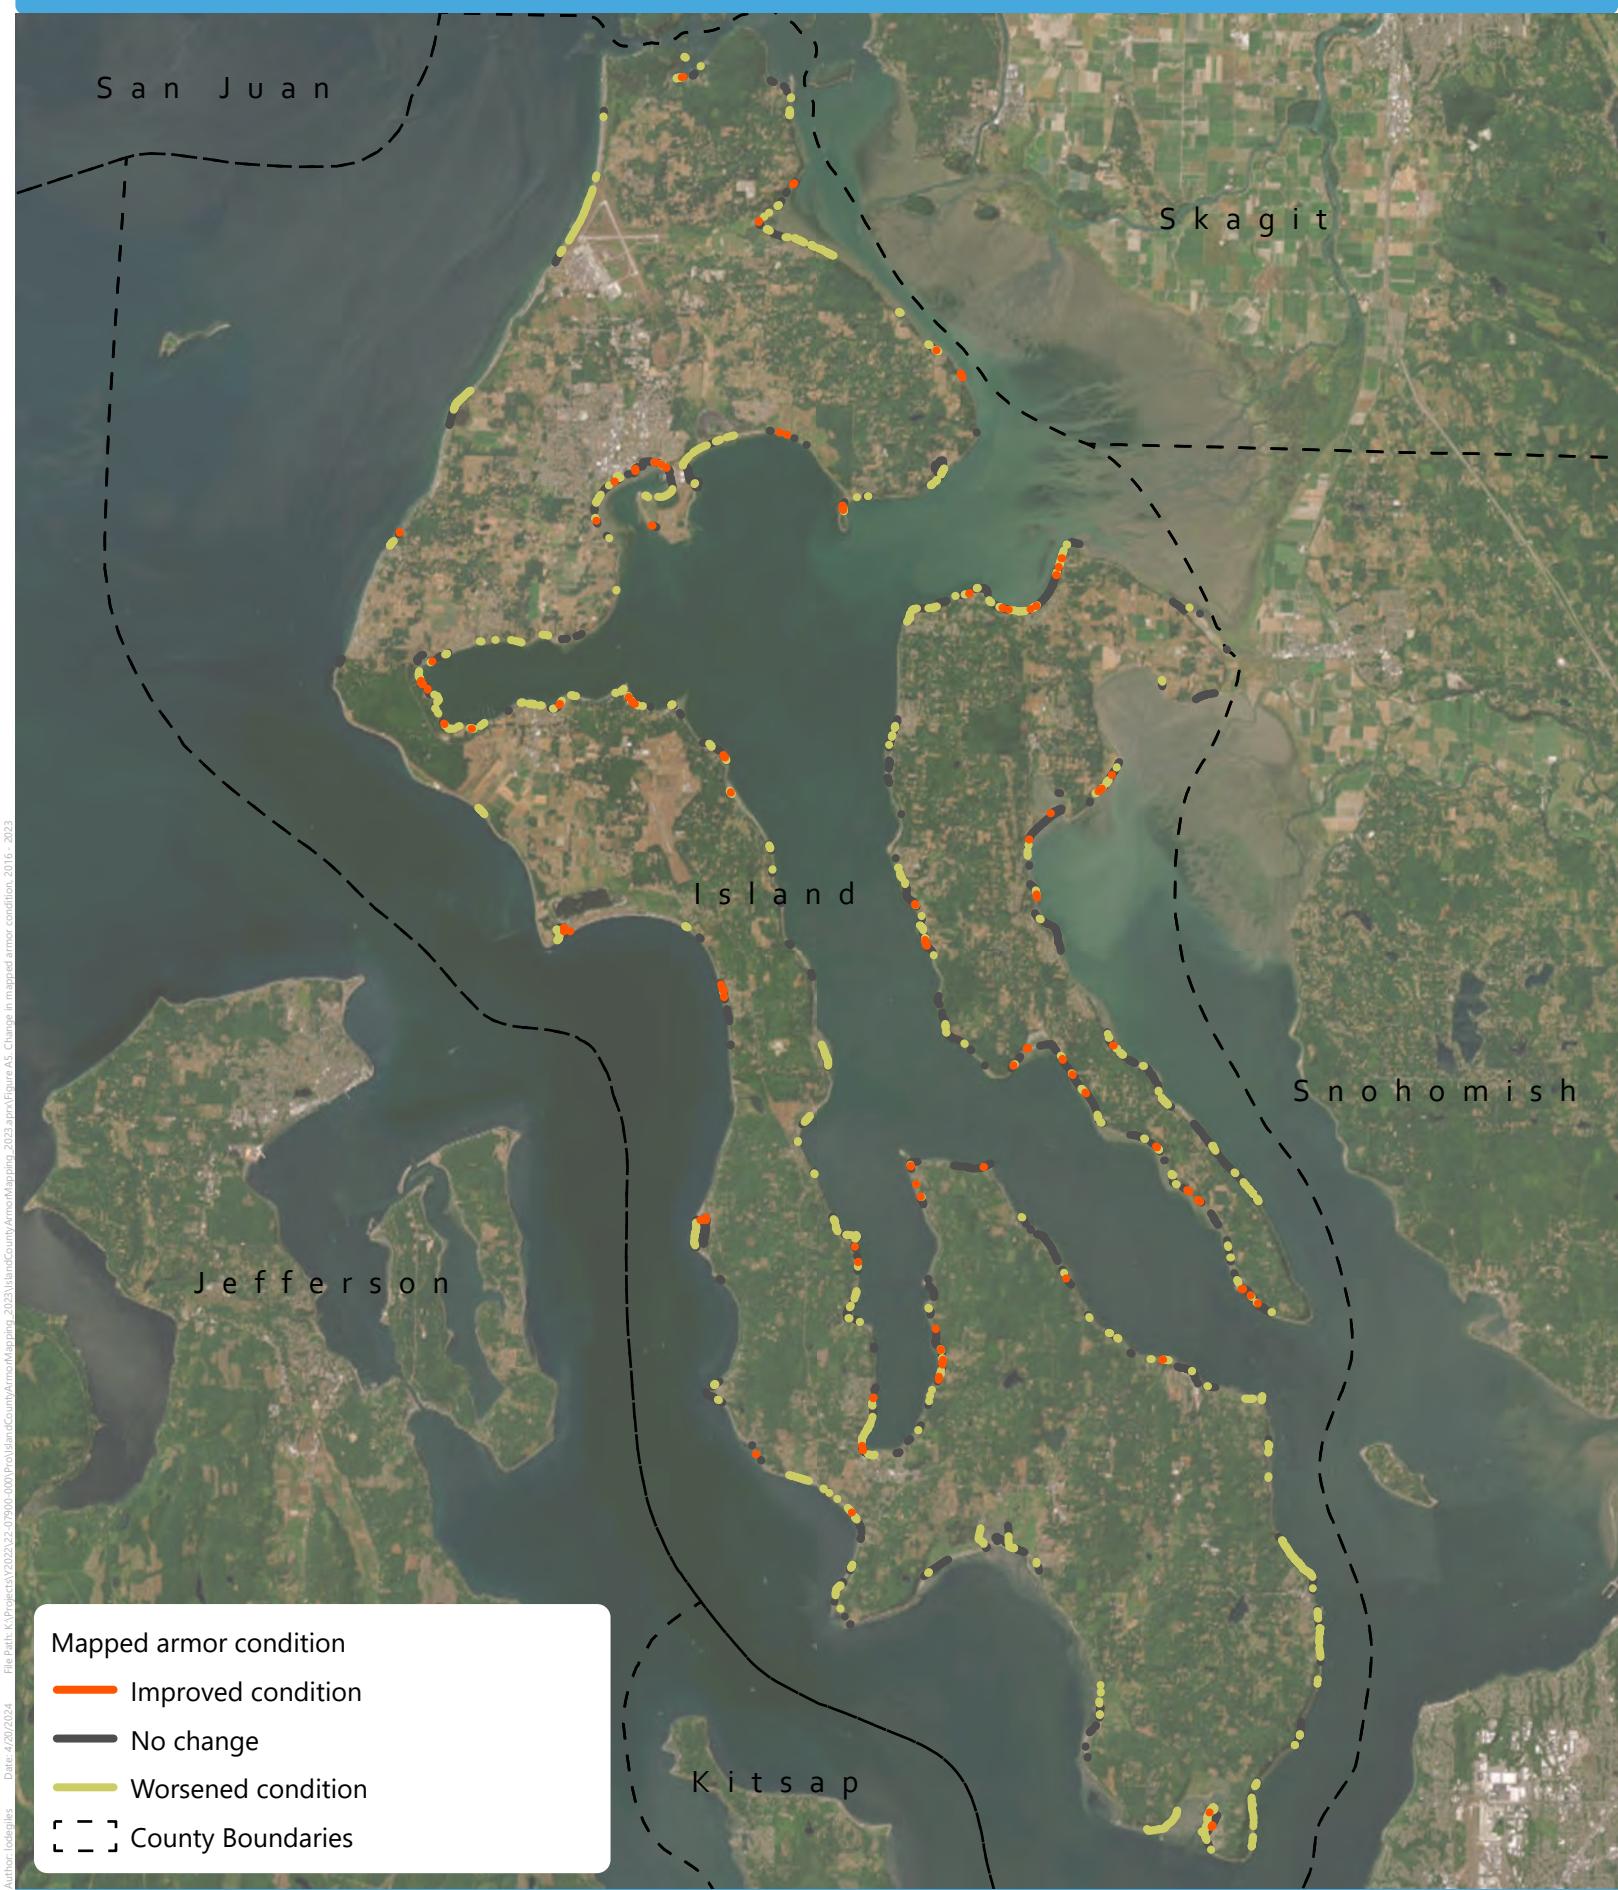
Figure A5.1 - Change in Mapped Armor Condition from 2016 to 2023, Island County

Of the approximately 271,300 feet of shore armor mapped in both 2016 and 2023, 261,300 feet (96 percent) either did not change in mapped condition (e.g., was mapped as "sound" in both 2016 and 2023) or worsened in condition (e.g., was mapped as "sound" in 2016 and "functional/failing" in 2023; Table 3). Mapped improvements in armor condition (from derelict to functional/failing, derelict to sound, or functional/failing to sound) were identified along 9,970 feet of shoreline (Table 3). The distribution of changes in mapped armor condition are included in Figure A5.

Overall, the condition of shore armor (armor present in both 2016 and 2023) appears to have worsened over the analysis period; 33,429 feet (12 percent) of extant shore armor was mapped as "functional/failing" in 2016, compared to 95,488 feet (35 percent) of shore armor mapped as "functional/failing" in 2023 (Table 3). Several recent, noteworthy winter storms resulting from king tide events that coincide with storm surge are potentially driving this overall degradation in armor condition. Some of this change in mapped armor condition may also be the product of differences in shore armor interpretation between the 2016 and 2023 survey events.

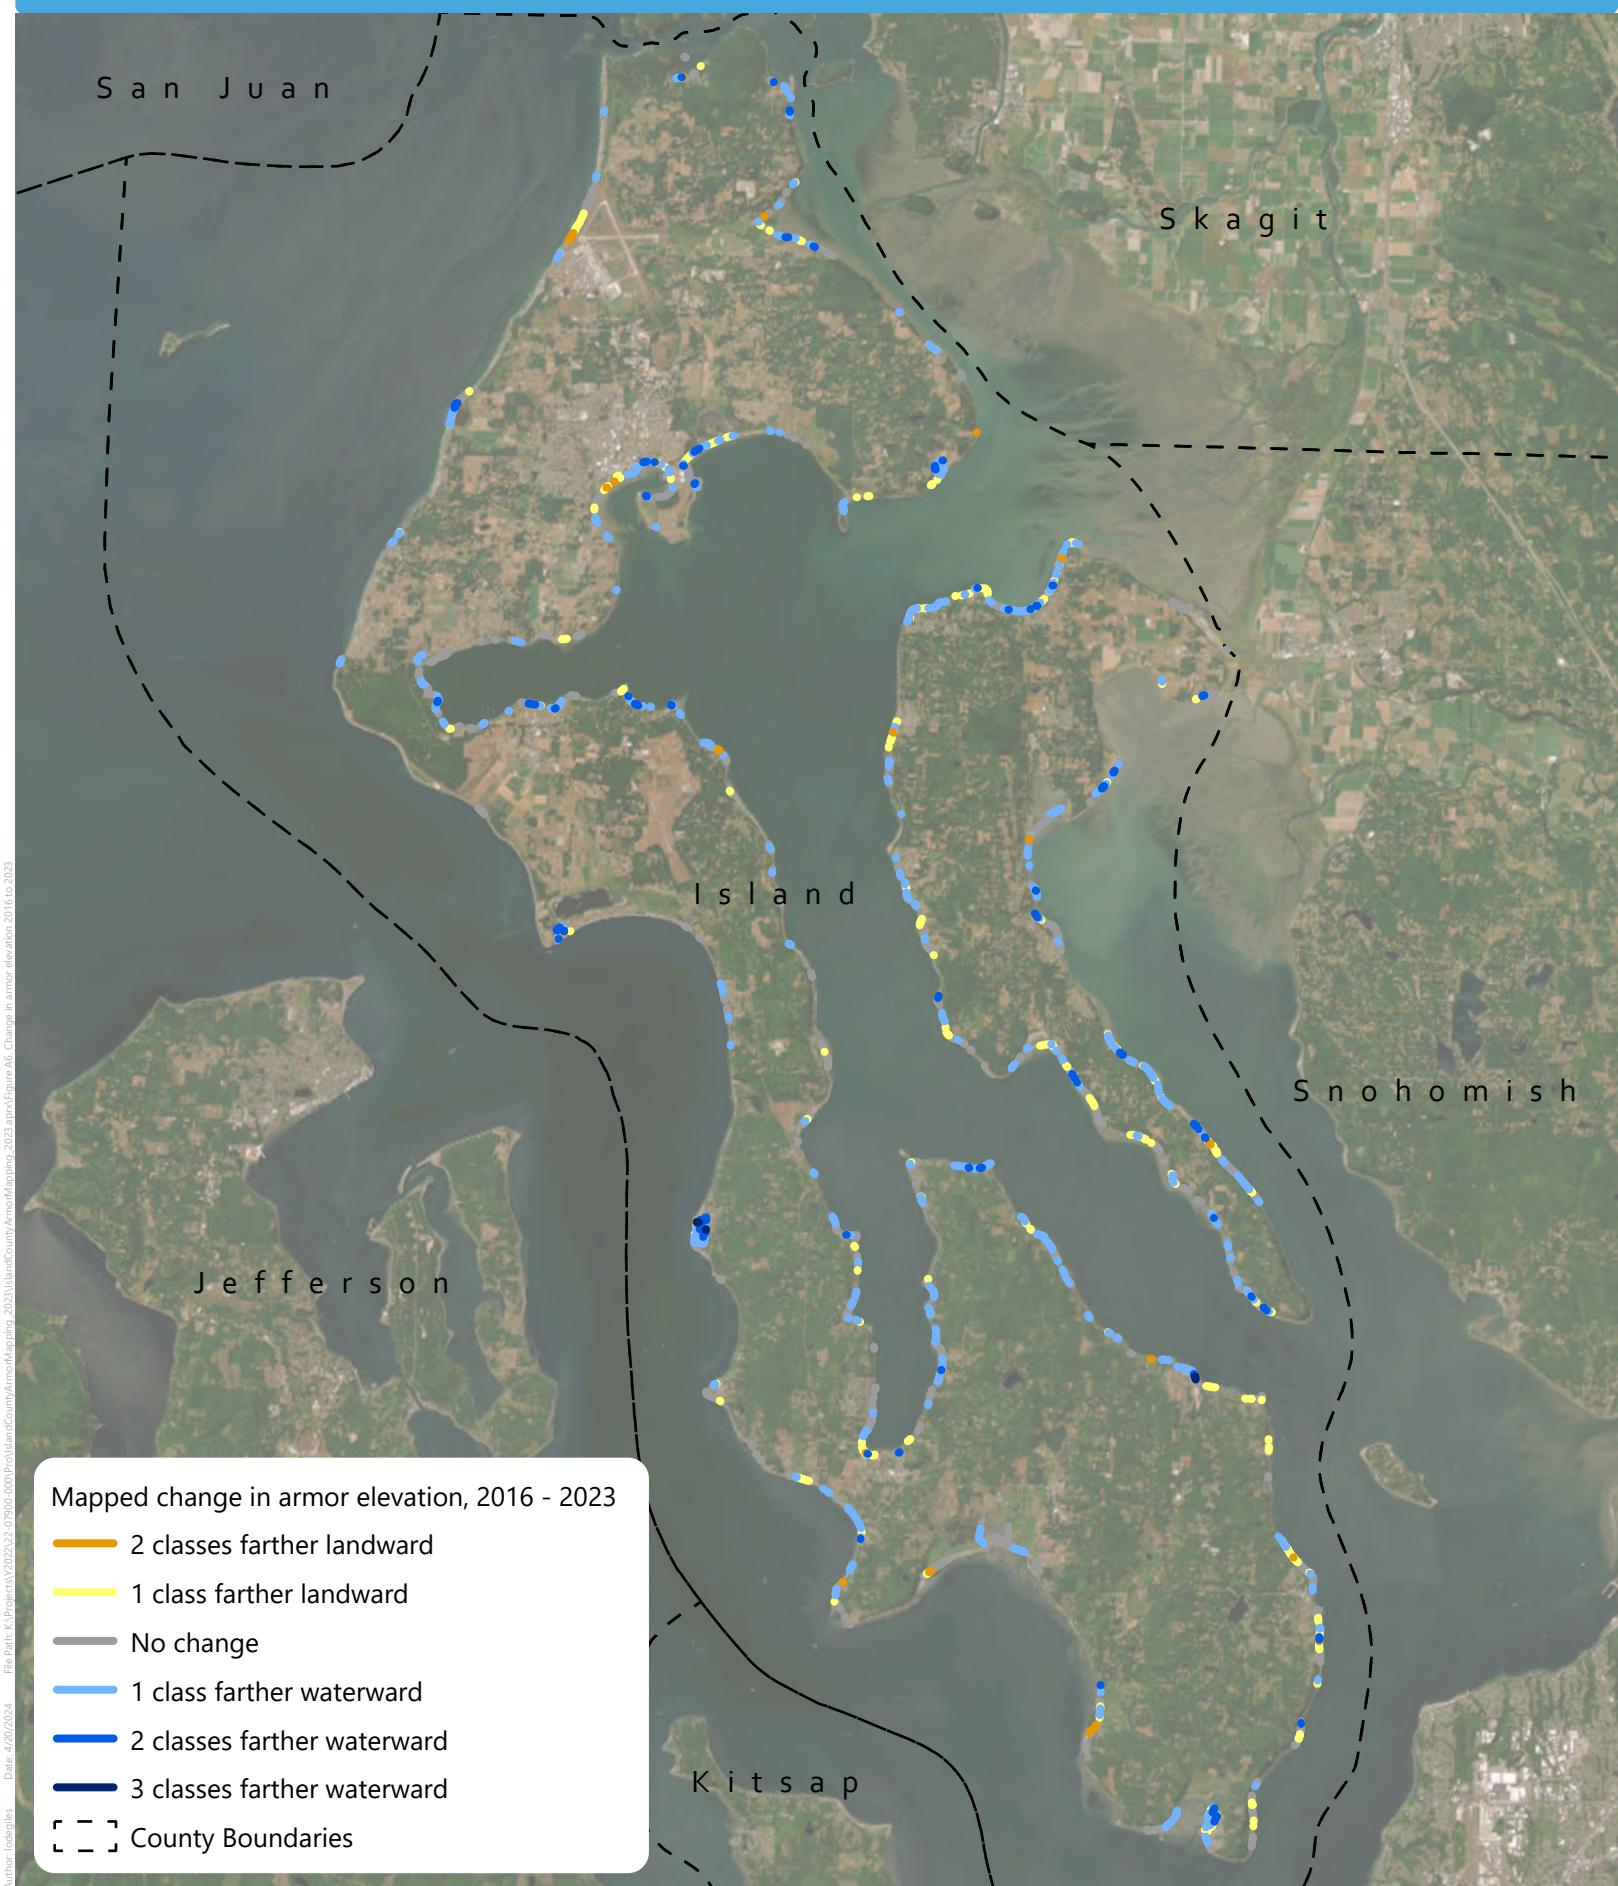
Figure A6.1 - Change in Mapped Armor Elevation from 2016 to 2023, Island County

Mapped changes in shore armor elevation between 2016 and 2023 were similarly compared, to identify areas where the direct impacts by shore armor had changed, whether through human-driven alterations to armor footprints or through the progressive degradation and breakup of shore armor over time (Table 4). Changes in armor condition were only evaluated where armor was mapped in both 2016 and 2023, and where armor condition was documented in the 2016 mapping records.
